# Low carbon construction using *Guadua* bamboo in Colombia

**Abstract.** *Guadua Angustifolia Kunth* (*Guadua*) is a tropical species of bamboo endemic to South and Central America and widely used as a mainstream material for construction in Colombia. Its rapid rate of biomass production, renewability, high level of CO<sub>2</sub> fixation and storage, wide diameter, long-length, and durability are distinctive and highly desirable features which can benefit the new built environment

The structure, properties and availability of *Guadua* are described in this paper. A case study on a recently built holiday house is presented illustrating the architectural, structural, environmental and technical performance of a *Guadua* building. This paper presents the construction process, discusses difficulties encountered during the building life cycle and highlights the need for similar assessments. It is concluded that with the aim of achieving a low carbon construction system using *Guadua* bamboo, challenges regarding manufacture, bio-deterioration, integration with conventional systems, and environmental impacts must be addressed.

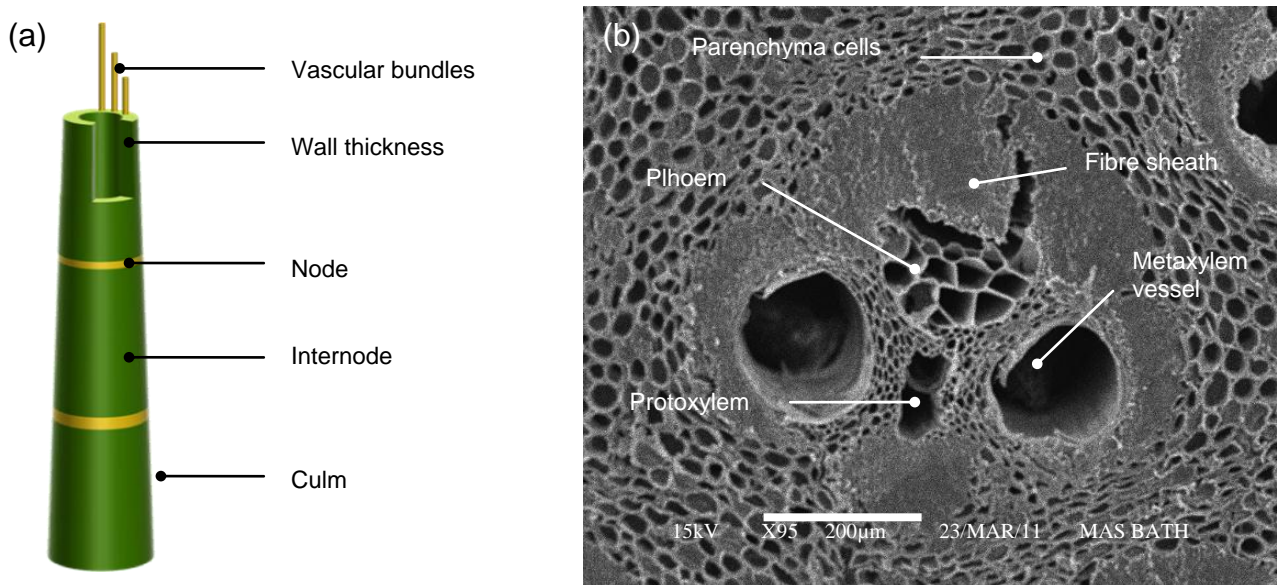
Figure 1 (a) bamboo culm, (b) vascular bundle (*Guadua Angustifolia Kunth*)

Commonly referred to as a giant grass, bamboo is an Angiosperm plant from the Poaceae –Gramineae family (grasses) which propagates rapidly by the expansion of underground rhizomes. Unlike trees, bamboos have only one growth stage where the culm (stem) seen in Figure 1a reaches its full height, diameter and wall thickness during the first four to six months of life. Subsequently, consolidation of tissue occurs by secondary thickening until maturity. The fast elongation of its culm is a result of the simple structure of fibres, conductive tissue and parenchyma units (Figure 1b) arranged axially along the stem which allows cellular differentiation and rapid flow of nutrients. As shown in Figure 1a, the continuity of the culm is interrupted by diaphragms that transversely connect the vascular system. The cortex (outer part) is rapidly consolidated with a high content of lignin and silica, providing protection for the load bearing tissue during growth. No growth occurs in the radial, longitudinal or tangential direction in the following years.

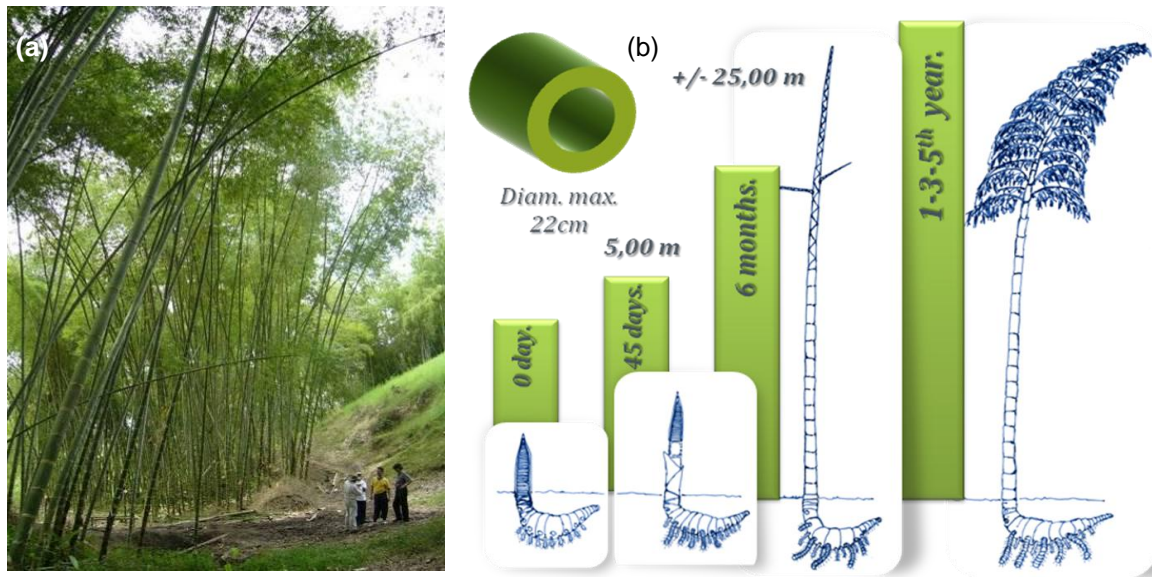
Figure 3 (a) Guadua plantation in Colombia, (b) Growth of Guadua culm

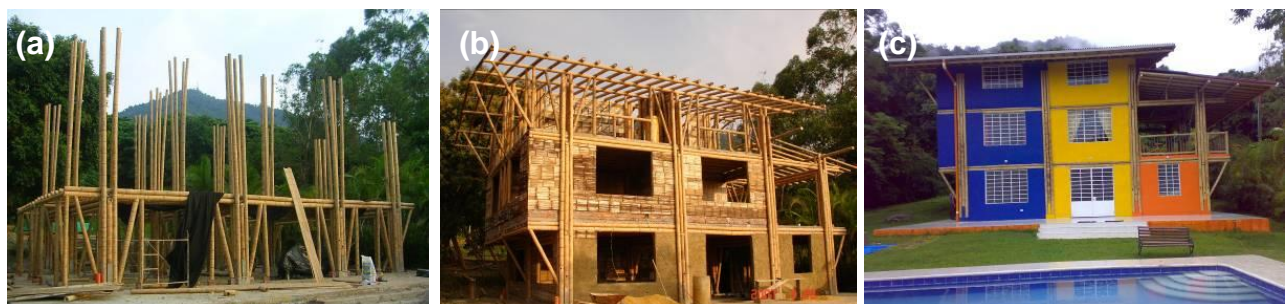
Figure 4. Construction process of a Guadua building (a) Framing (b) Walling (c) Finishing

Figures 4a, b and c show the construction process for a building that combines systems (a) & (b) in a three storey holiday house in Colombia.

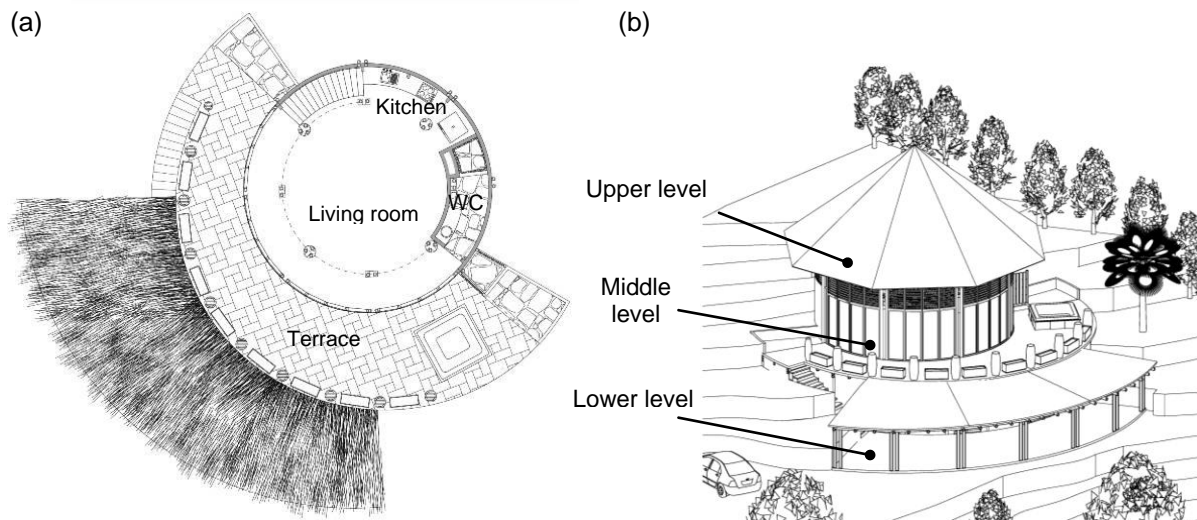
Figure 6. (a) Principal floor plan of Bohio. (b) Three dimensional view of Bohio.

As shown in Figure 6 a & b, this sloping plot allowed a three-level arrangement of the building to be constructed which resulted in separation into three functional zones: a private suite at the top level, a social area in the middle and an auxiliary accommodation and services area on the bottom floor. The middle zone contains an open kitchen and the living room which can be extended to the front terrace and serves as a transition to the lower level where guest, laundry and storage rooms are located. This distribution resembles the spatial hierarchy found in vernacular buildings where the building core contains the main zones (private and social) and auxiliary rooms are located in an external concentric zone.

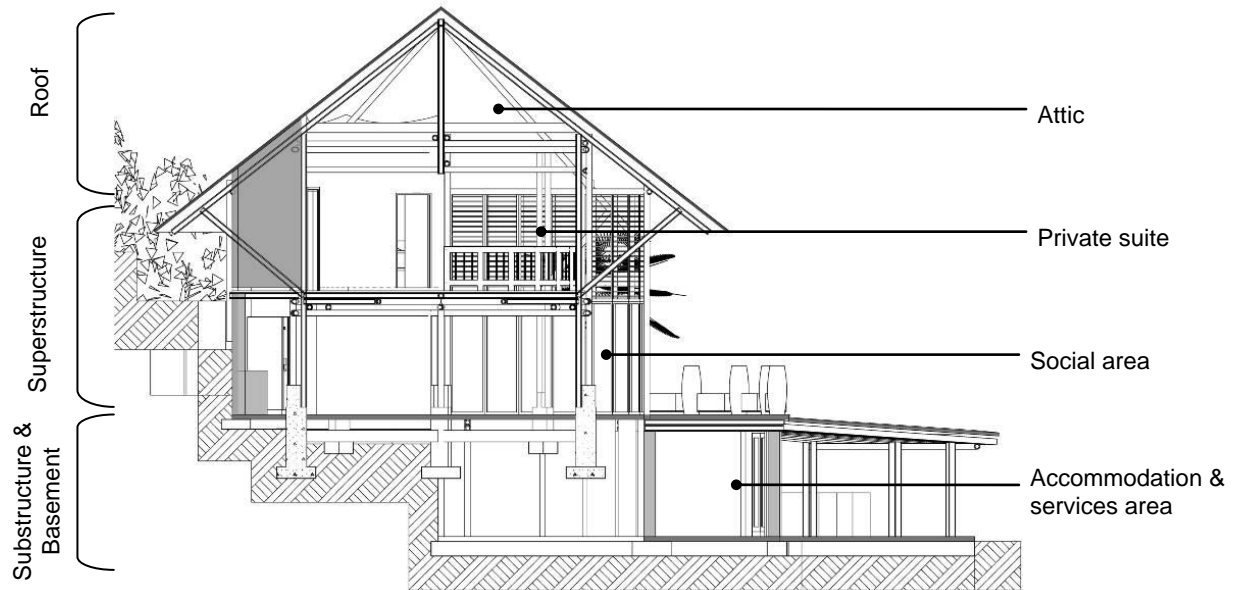
Figure 7. Bohio's structural and functional zones.

Bohio' structure (Figure 7) can be divided into three parts: the basement (substructure), the superstructure and the roof.

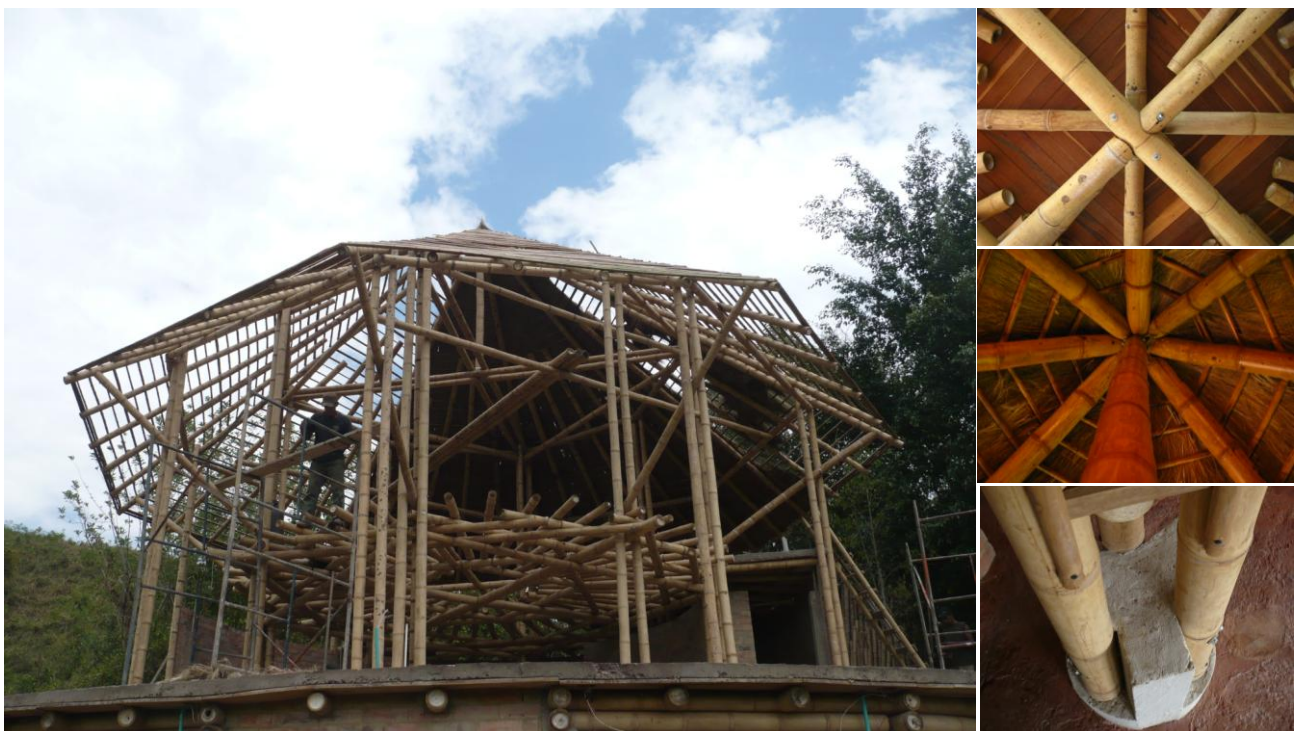
Figure 8. Superstructure of Bohio project. Smaller images show (top) the floor, (middle) roof and (bottom) three-flanged reinforced concrete pedestals.

The basement is basically a solid box with a continuous retaining wall which contains the abutting ground. Its base is made out of reinforced concrete, and its walls of fired clay bricks strengthened with concrete piles to restrain lateral deflections. The foundation of the superstructure (Figure 8) consists of four main and four secondary concrete isolated footings interconnected by ground concrete beams. Three-flanged reinforced concrete pedestals emerge above ground from these footings to connect with three Guadua columns using bolts.

Four bamboo columns composed of three elements set the edges of the main square frame and there are four additional two-component Guadua columns which define a secondary square which sits within the primary square but rotated by 45°. Each edge of the squares is connected by Guadua beams forming an octagon in the first and second levels of the structure. A radial arrangement of bamboo joists supports the timber decking of the first floor, while the roofing system lies on the top of the superstructure. An exterior frame system holds the facade and gives some extra support to the roof. The roof joist converges to the centre from the eight sided structure beneath, reaching a height of 8.00m above the ground floor.

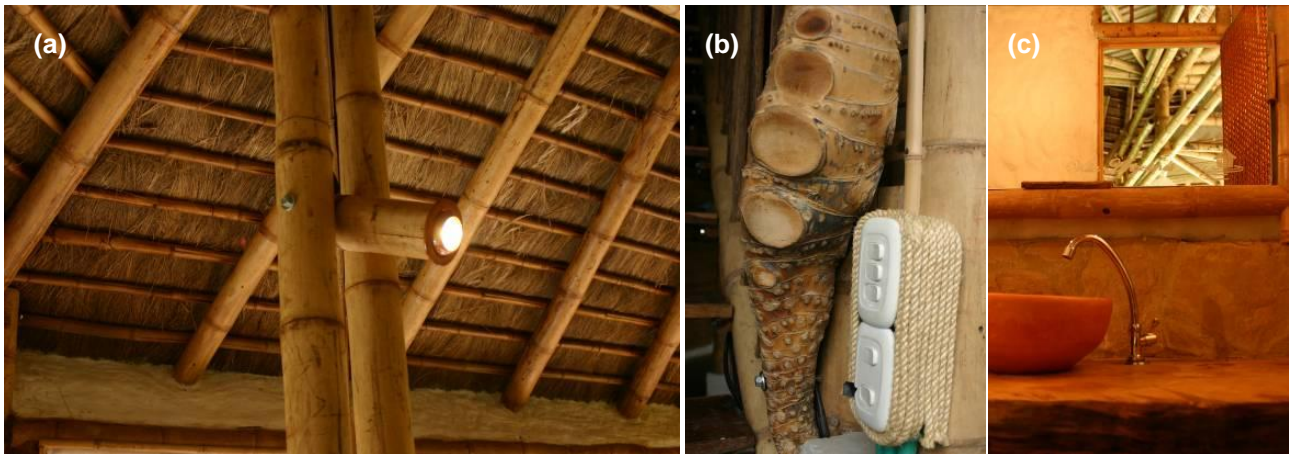
Figure 9. Architectural details of Bohio's Project (a) Ceiling (b) Installations (c) finishing details

The main components of the roof cladding (Figure 9a) are a corrugated steel sheet sandwiched between straw bunches with and a polyethylene membrane between the steel sheet and the inner layer of straw. Support is provided by Guadua-roof joists that converge in the centre of the conic roof. Parallel Moso bamboo roof battens arranged in the horizontal plan along the eight triangular sections of the roof tie together the straw bunches. The space left underneath by the 45 degree inclination of the roof gives room for an attic which is subdivided into a two-storey triangular set of bunks.

The electric installations are spread across the building with rubber flexible cable (3 x 12 AWG). The absence of cladding leads to aesthetic issues due to the difficulties of embedding cable inside the Guadua or hiding it in a skeleton-like structure. Where possible cable was covered by half bamboo canes as shown in Figure 9b.

Figures 9b & c show internal features where the design and selection of materials follow Bohio's architectural concept. Clay fired accessories for bathroom basins (Figure 9c), a wooden staircase, fitted furniture and gas lamps were inspired by vernacular architecture and regional traditions. Rattan fibres are specified for door faces and bed headboard, sisal cords for covering exposed installation pipes. The completed building is presented in Figure 10.
